June 2019

REPORT ON AISWCD OFFICE BUILDING

SECTION 2A: INSPECTION REPORT

**Property Located At:
4285 North Walnut Street Road
Springfield, Illinois 62707**

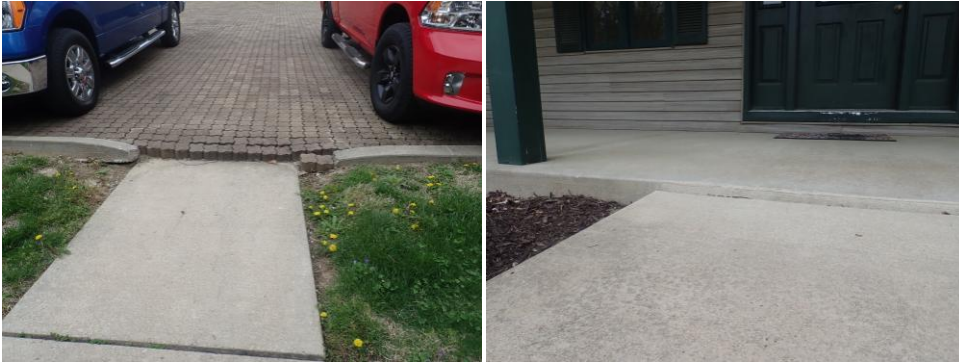
Comments: Small lip from walk to parking lot. One brick height difference. Small settlement to porch.

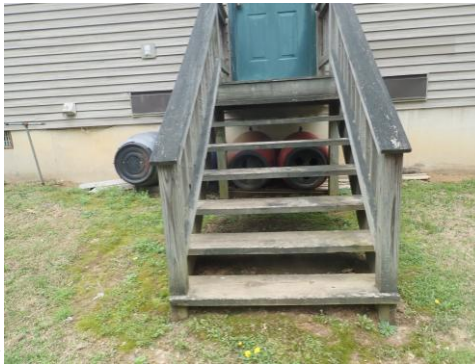
Comments: Rear steps missing center riser. Wood starting to decay. Slick with moss on surface.

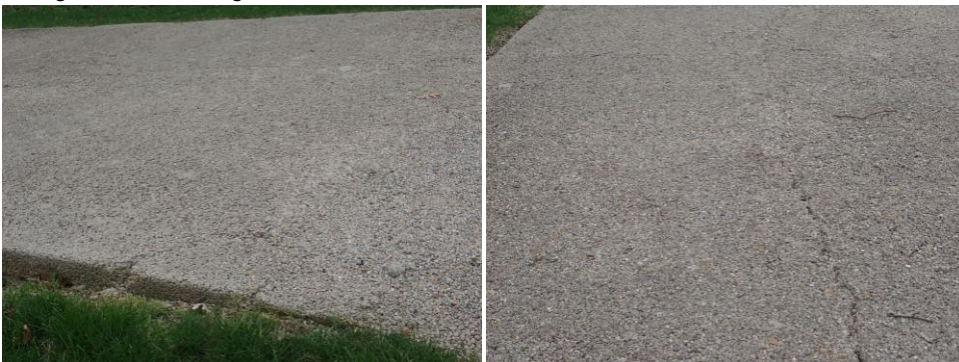
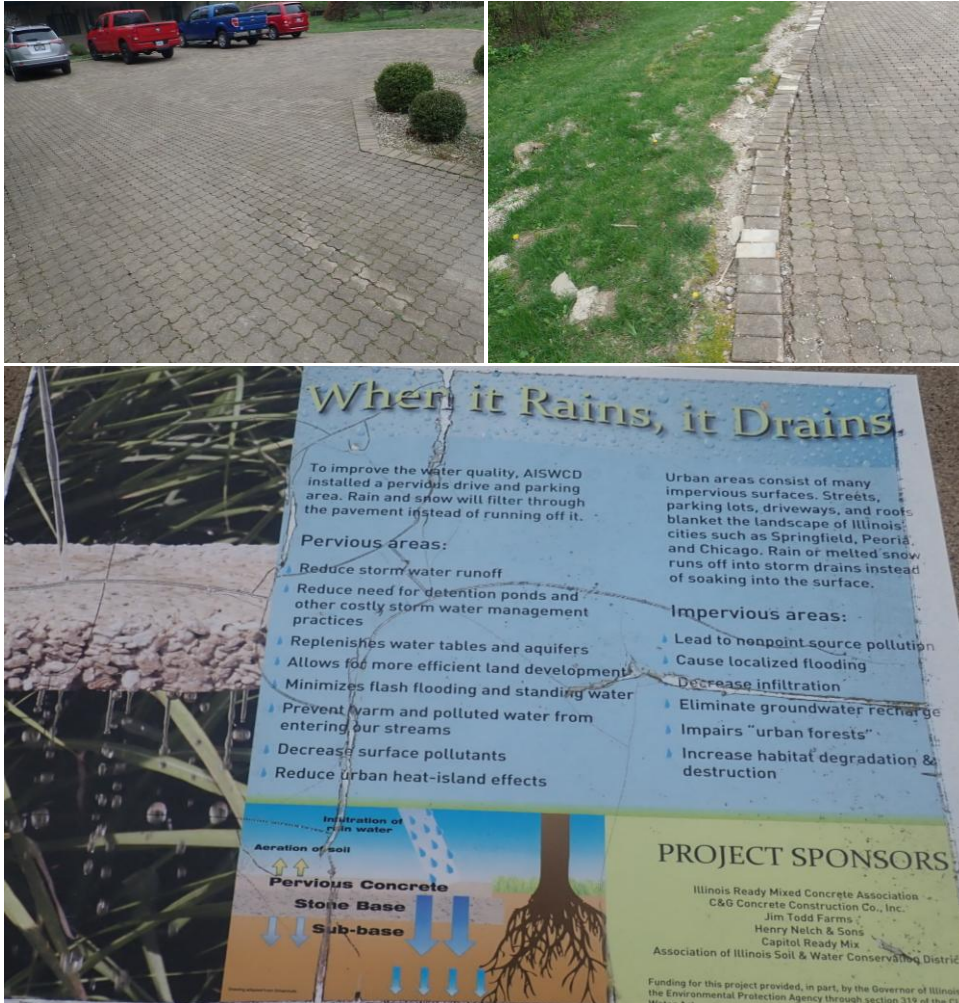
Comments: Special rock is cracking, pot holes and crumbling. Pavers in parking area okay except along edge a area where snow plow pushed them out of position.

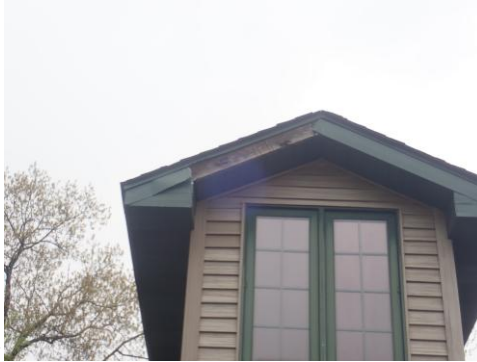
Trim: Wood, Metal, Vinyl
Comments: Trim missing and damaged front dormer.

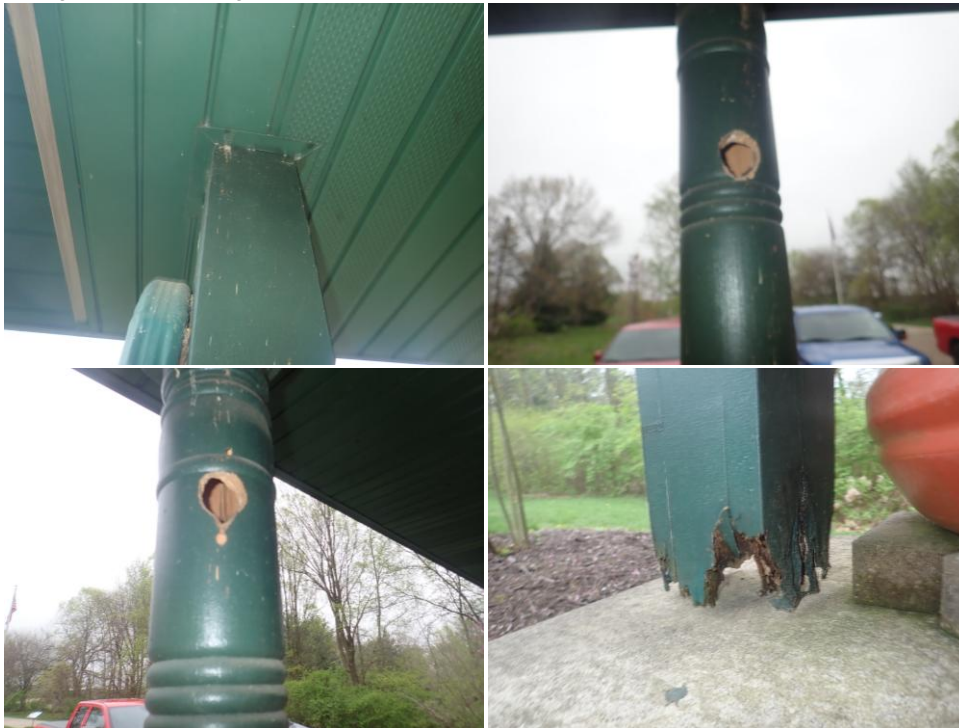
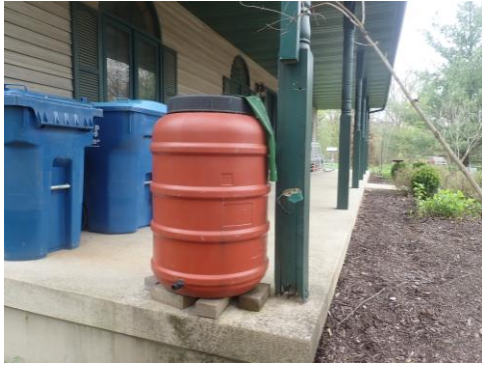
Porch:
Comments: Porch columns have enough rot, insect and bird damage that is no longer supporting anything. Time to replace.
Rating: Marginal/Fair

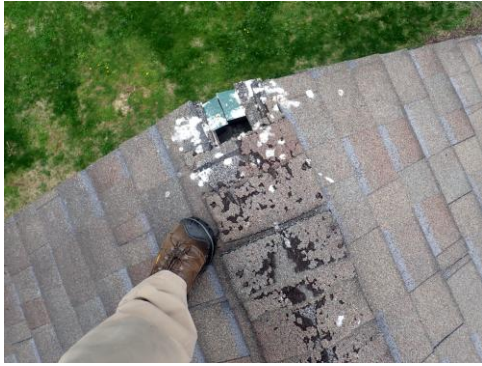
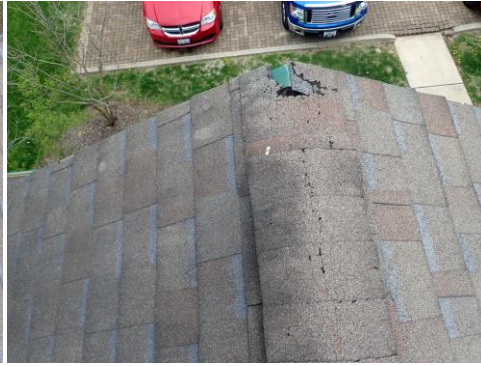
Comments:	Roof old and time to replace. Could do some patching/replacing of cap shingles and roof boots, etc. My opinion is that it is time for a new roof. See photos. Currently leaking at ridge cap and boot flashing.
Rating:	Marginal/Fair

Holes at the edge of each gable end of roof.

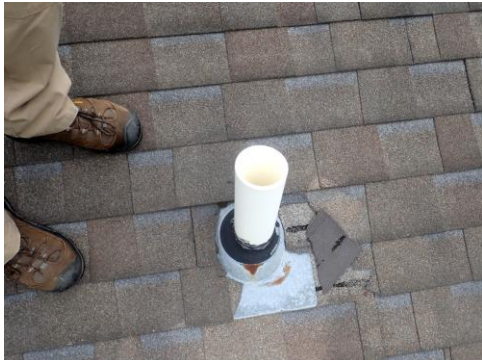
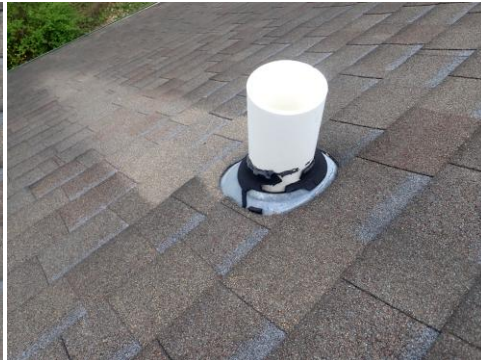
Plumbing boots leaking - The rubber neoprene boot has split and deteriorated due to age.

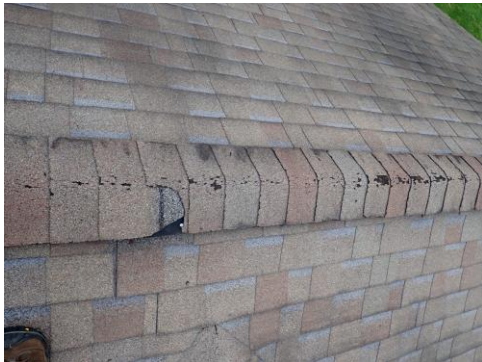
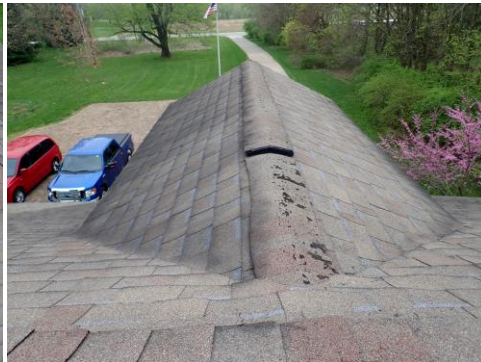
Cap shingles need updated ASAP or best would be just replace roof.

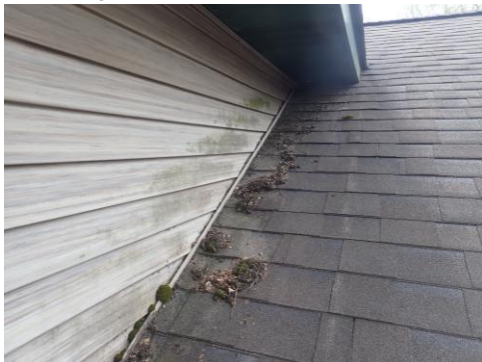
Moss growing under shingles and siding.

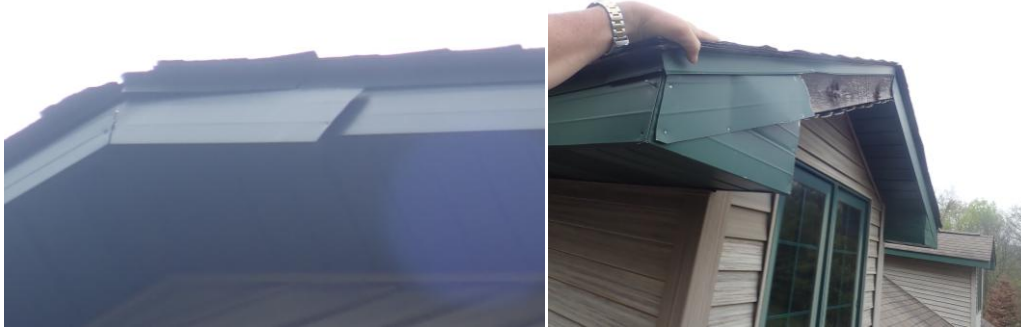
Fascia: Metal
Conditions: **Loose trim ---** Trim is loose and should be repaired. Recommend repairing or replacing as needed.
Comments: Loose piece in gable.
Rating: Marginal/Fair

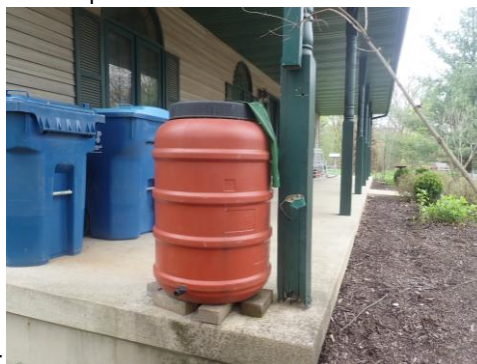
Down Spouts: Metal
Comments: Need extended or re-position and catch in rain barrels.

Rating: Marginal/Fair
Water missing rain barrels is causing rot to post.

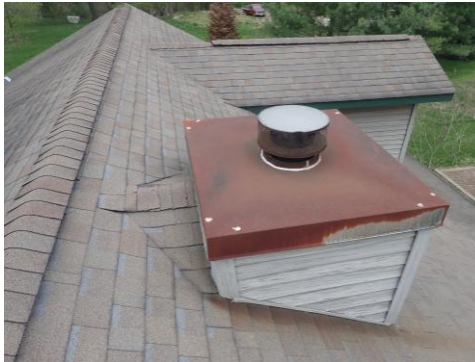
Chimney: Metal
Comments: Rusty metal chimney cap. Time to properly update.

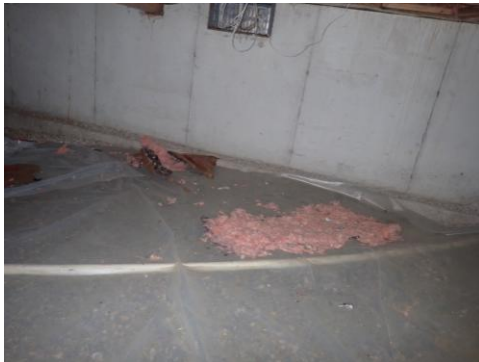
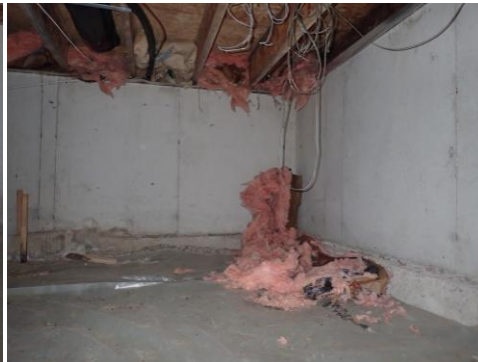
Floor: Fiberglass
Conditions: **Falling insulation** --- Portions of the insulation is falling from its original position. Have the affected areas reattached properly.
Comments: Falling down out of place and need replaced.
Rating: Marginal/Fair

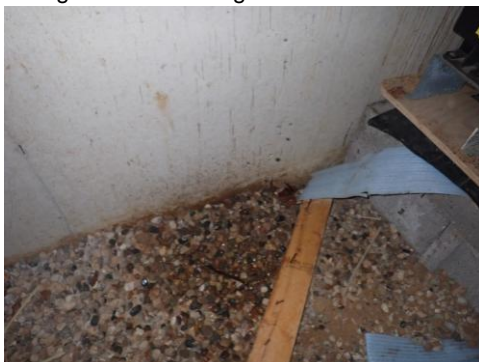
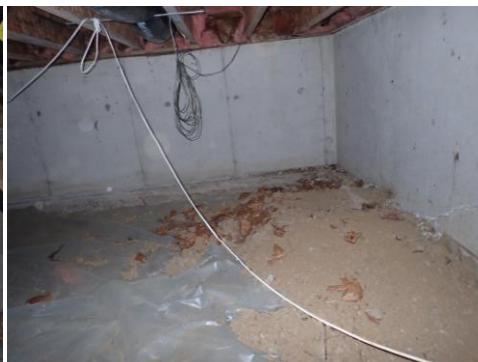
Methods: Vapor Barrier
Comments: Missing in areas. Recommend adding where missing.
Rating: Marginal/Fair

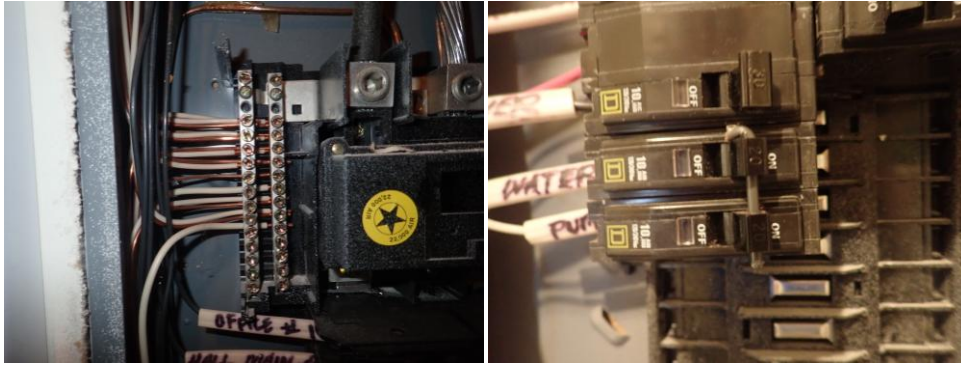
Comments: Double tap neutrals. Not a proper 220 connection for breaker. Both fairly easy repairs.

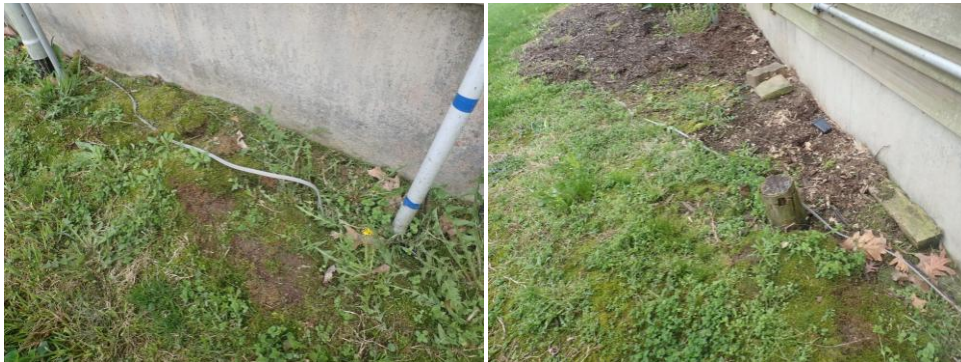
Comments: Wire lying along the side of the building needs properly secured.

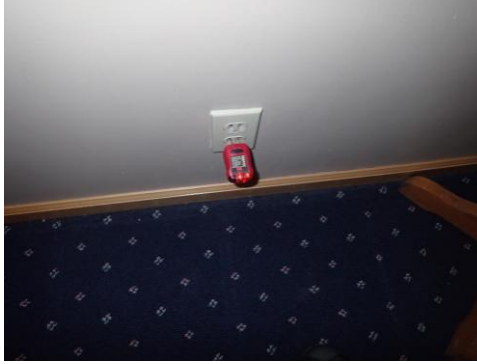
Conditions: **Loose receptacle** --- Electrical receptacle was observed to be loose. The receptacle should be properly reattached in order to prevent a shock hazard.

Comments: Loose outlet in front room. Just secure better.

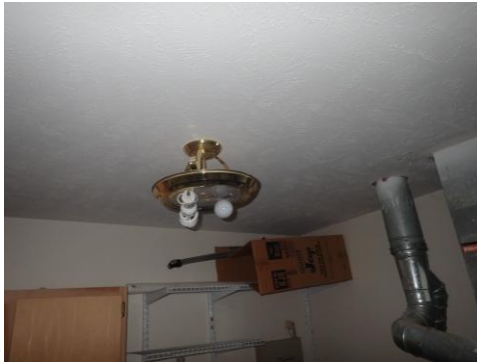
Fixtures: Fixtures
Comments: Missing globe in storage area.

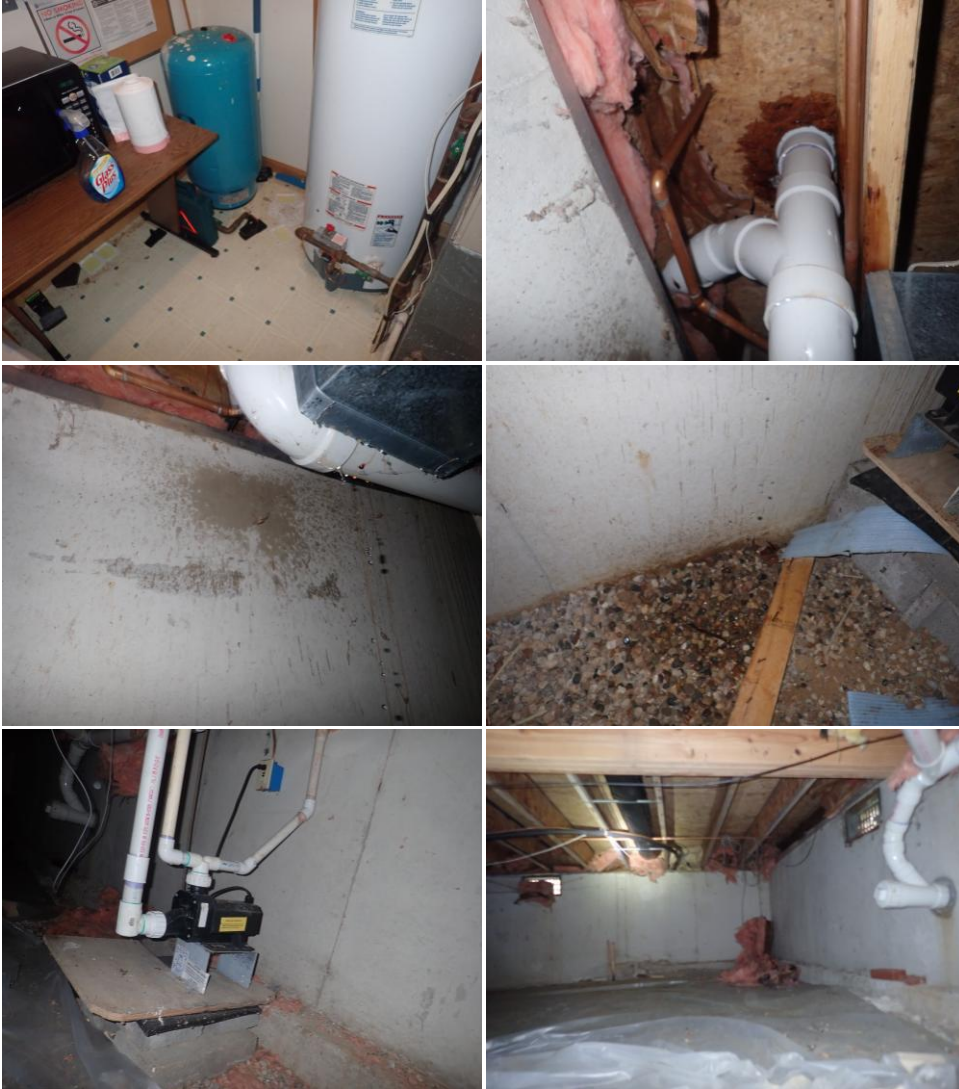
Piping Mat: Plastic
Comments: We do not inspect septic but lines obviously clogged or collapsed. I ran water in all sinks, toilets, sinks, and whirlpool as always and sewage stopped leaving structure. Started coming out at base of toilets and drain for HVAC, etc., before tub had a chance to drain. I noticed this as I was in the crawl and came up out of the crawl to help clean up leaking water at toilets and floor drains. This building needs all plumbing waste lines and septic evaluated and properly updated to drain sewage out of the building. It is a health hazard to leak plumbing waste inside a structure and it should be properly cleaned and sanitized. Grant stated the plumbing has done this in the past also.

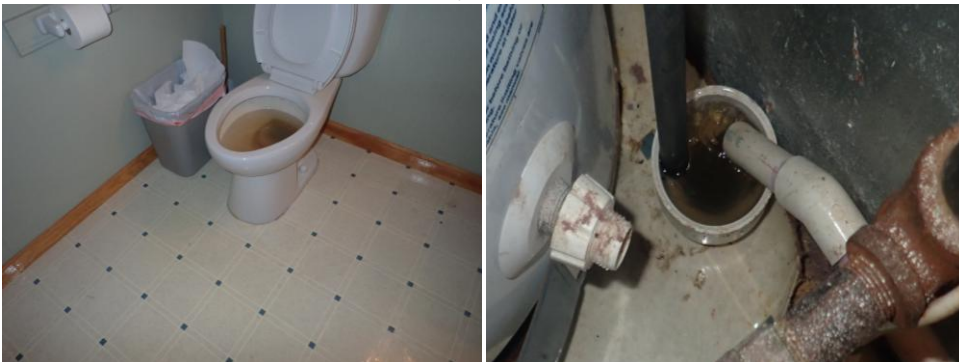
May have a grey water reclaim device below each bath tub etc. I came out of crawl so fast once I saw water leaking did not go back down to evaluate - you need a plumber on site to have him evaluate all plumbing waste and drain and supply and reclaim systems and determine if they are working properly. With water dripping off of all the pipes I cannot determine what if anything was leaking. Also evaluate and update and maintain water treatment system. We do not check septic system but it could also be the issue.

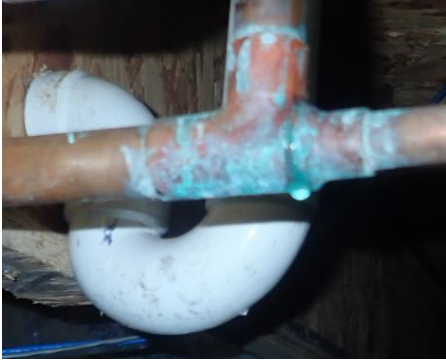
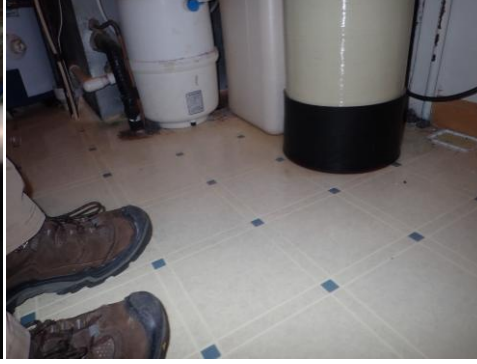
Water leaking out of base of toilets and floor drain by furnace.

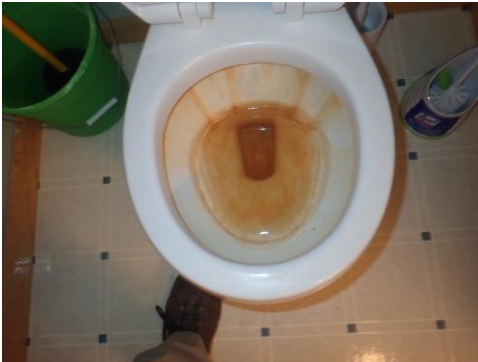
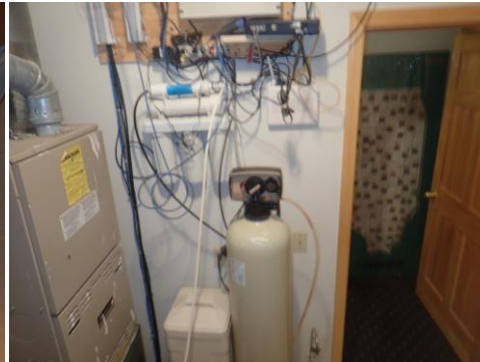
All lines wet from water backup. Leaked on floor by furnace.

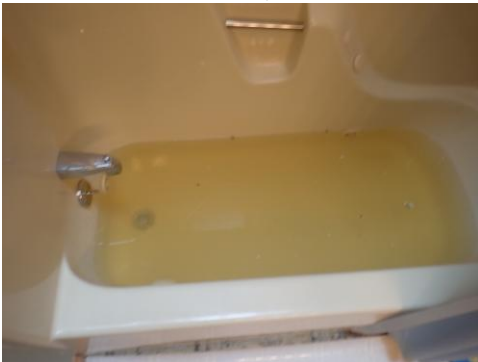
Water had a bad smell and color as it flowed out of the faucets - needs the water purification system updated on maintenance and repaired - change filters and make sure it is working properly.

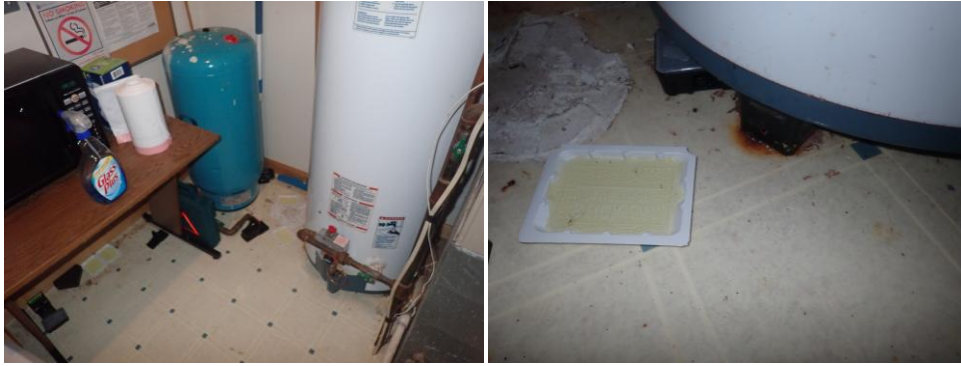
Comments: Should not be sitting on sheet vinyl flooring. Should have a catch pan under unit when on the main floor.

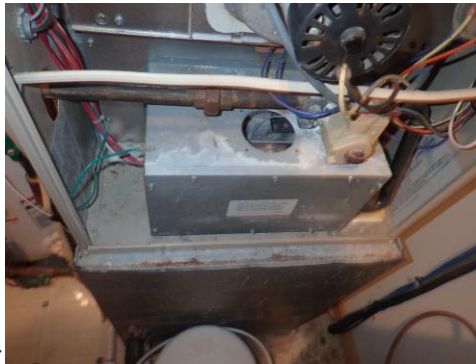
Comments: Blower door safety switch missing. More rust than normal inside unit. Still working but fair rating due to age and condition of unit.

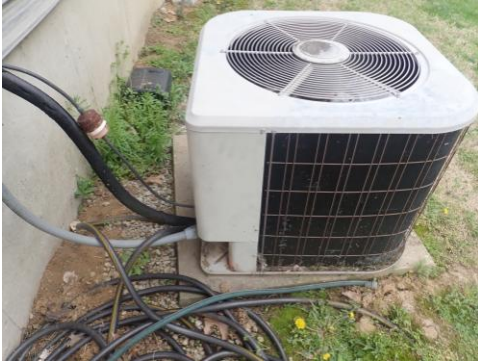
Conditions: **Too Cold to Inspect ---** It was too cold on the day of the inspection to test this unit. Its rating is unknown.

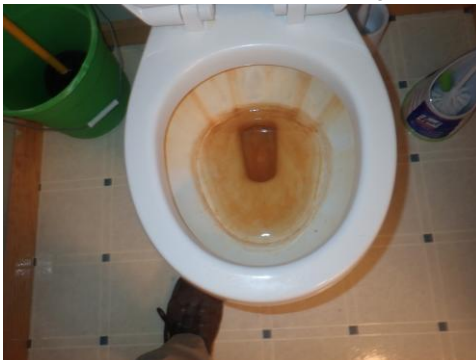
Floor: Sheet vinyl
Comments: Toilet stained so much discolored and will no longer clean up.

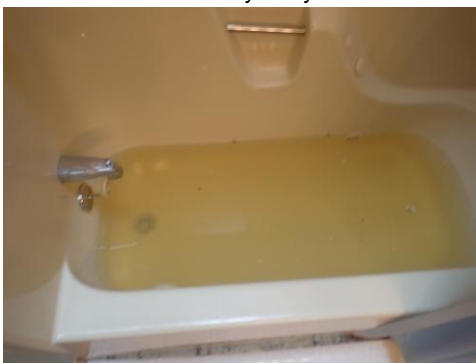
Tub/Shower: Main, Tub/Shower, Whirlpool
Comments: Whirlpool Tub did not run. Water very rusty and smelled bad.

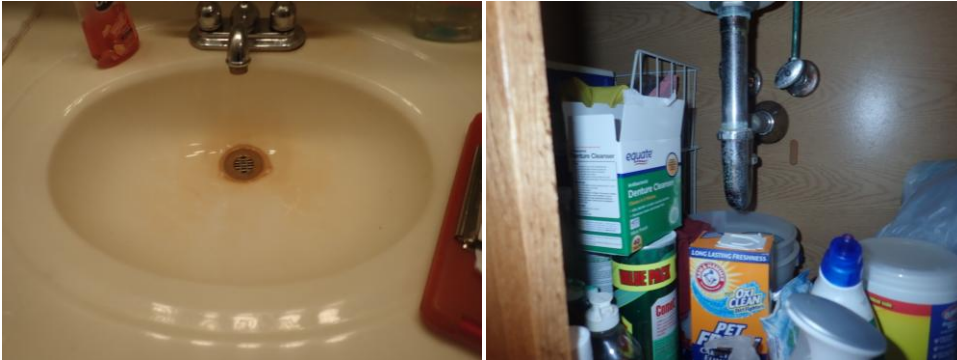
Fixtures: Vanity
Comments: Stained with rust deposits. Corrosion on drain lines.
Rating: Marginal/Fair

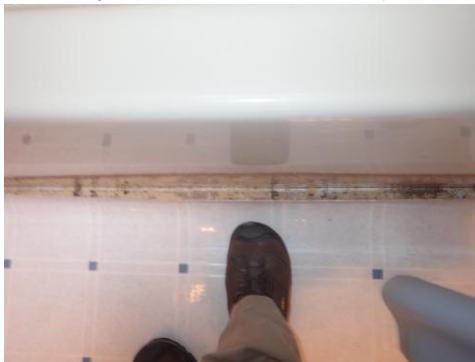
Floor: Sheet vinyl
Comments: Curled and loose along tub. Repair or replace vinyl floor.

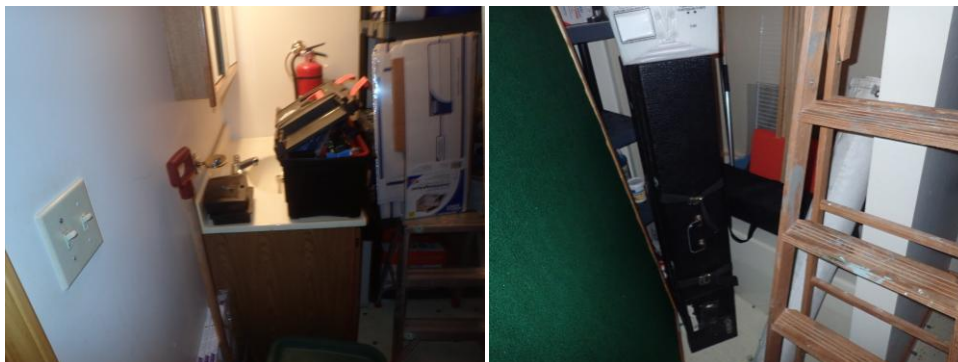
COMMENTS: Third bath partially removed and used for storage closet at this time. Not tested.

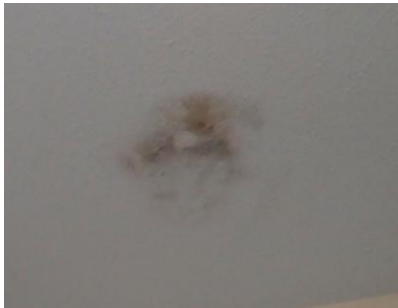
Type: Wood, Drywall
Conditions: **Cracks (minor)** --- Some cracks were noted that are minor in nature.
Stained --- The material is stained. Some stains may be very difficult to remove. Before repairing, be sure the source of the stain has been located and cured.
Comments: Ceiling damage and stain from leak in roof plumbing boot in hall outside bathroom, over furnace and starting to develop mold growth. Stop leak and clean and treat and then repaint.
Rating: Marginal/Fair

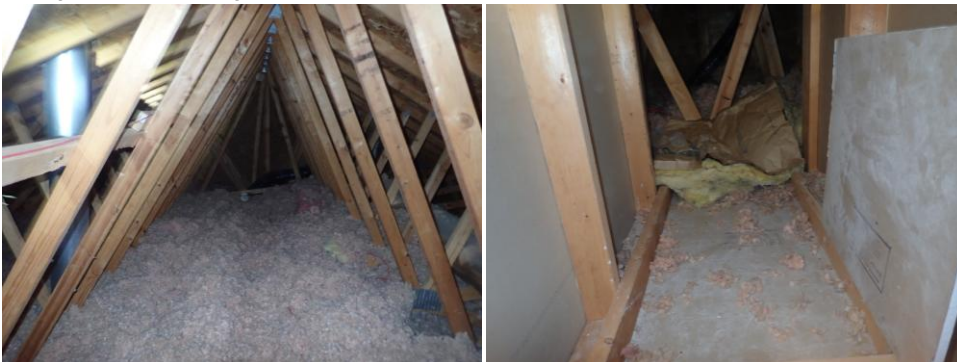
Insulation: Fiberglass
Comments: No insulation over closet where access is located. Recommend adding insulation.
Rating: Marginal/Fair

Main attic looks good just insulate closet ceiling.
