June 2019

REPORT ON AISWCD OFFICE BUILDING

SECTION 2A: INSPECTION REPORT

**Property Located At:
4285 North Walnut Street Road
Springfield, Illinois 62707**

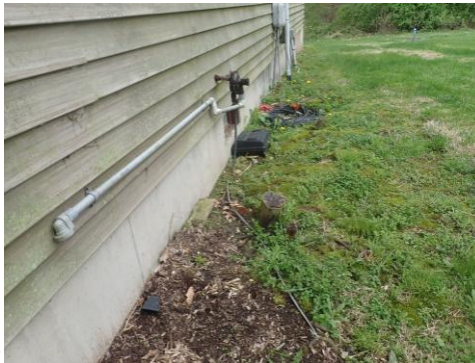
Comments: Negative grade along side of home.

Rating: Marginal/Fair

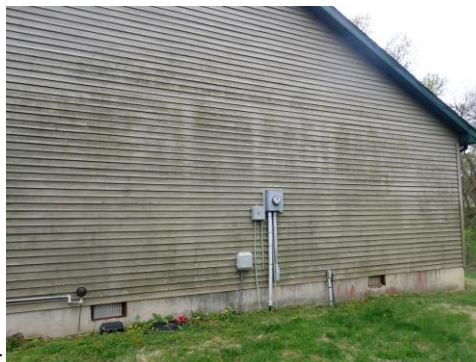
Rating:

Marginal/Fair

Clean off moss and mildew.

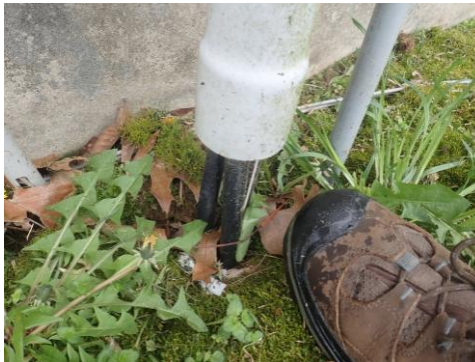
Comments: Exposed wires where ground washed away needs corrected. Safety issue.

Rating: Marginal/Fair
